Date of Inspection: 5 August 2020
Site Name: Springs Road No 2
Site Code: 1136/M
District Council: Bassetlaw
Development: Exploratory wellsite
Operator: Island Gas limited
Present: John Cranham & Tim Turner - NCC
IGas

Visit to the site as part of a routine monitoring programme to check compliance with the Conditions attached to the planning permission and legal agreement. The last inspection was carried out on 5 February 2020. The site entered the Evaluation Phase on the 1/5/2019 and remains in this Phase.

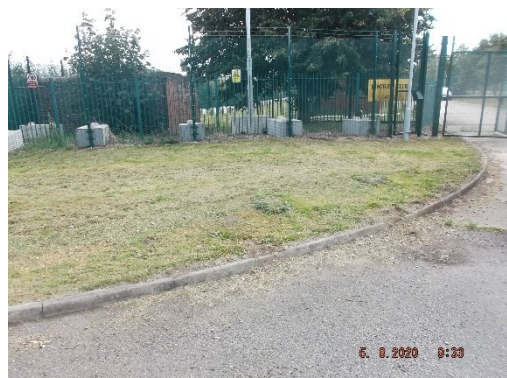
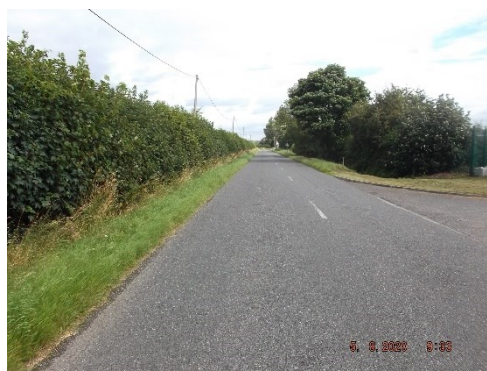
The inspection commenced from the entrance off Springs Road which was clean and tidy. The grass verge of the bell mouth was supporting a well-established grass sward which had recently been mown. The verges of Springs Road also continue to support a well-established grass sward. The concrete access road into the site was clean and tidy with the security hut remaining at the side.

Grass verge on Springs Road

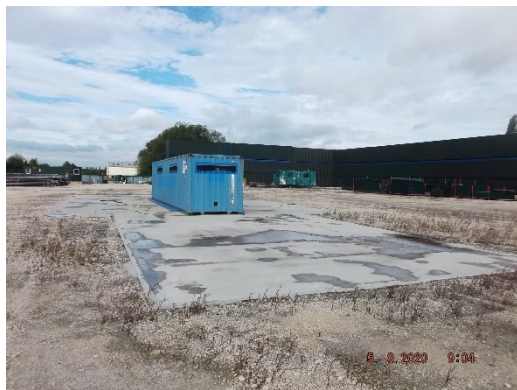
In the well pad area the container wall remains around the pad with five containers having been removed from the second level and placed in the north east and south east corners of the pad for use in storing valuable and sensitive equipment. The blue container remains over the well cellar along with the housing for the generators used during drilling operations in the south east corner. In the north west corner remains stacked equipment and fencing panels which continue along the northern section of the pad. Further equipment is stacked around the south west corner of the pad along with drill rods along the western boundary. The portacabin and small container along with two black storage tanks remain on the concrete missile pad west of the well pad.

Container over Well Cellar

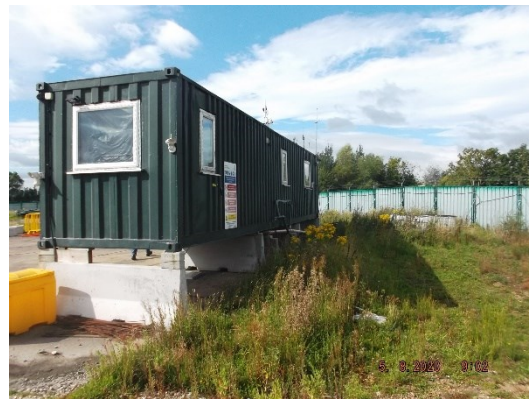
Portacabin
